# **Spatial Analysis of Gully Erosion Control Measures in Gombe Town, Gombe State Nigeria**

The performance of gully erosion control measures in Gombe metropolis is presented. This paper aimed at assesses the spatial distribution of gully erosion control measures in Gombe town since 2004 to 2015. The objectives of the research are to identify the spatial distribution of gullies in Gombe town and to analyze the length of gullies so far checked or controlled. High resolution images of the study area (Quick bird 2004 and 2015) were acquired for GIS analysis and ground truth measurement. Information gathered from field and image digitization was used to determine increase in the size and length of gully erosion from 2004 to 2015. In order to identify recently developed gullies, ArcGIS software was used to perform spatial analysis. Result of the study revealed that most of the previous uncontrolled or partially checked gullies have increased in length to 131.02 km as against the 121.50 km in 2003. This represents an increase of 9.72 km (7.42 %) over the 13 years period or about 75 metres annual increase in gully length. The analysis further revealed that there were 615 first order gull

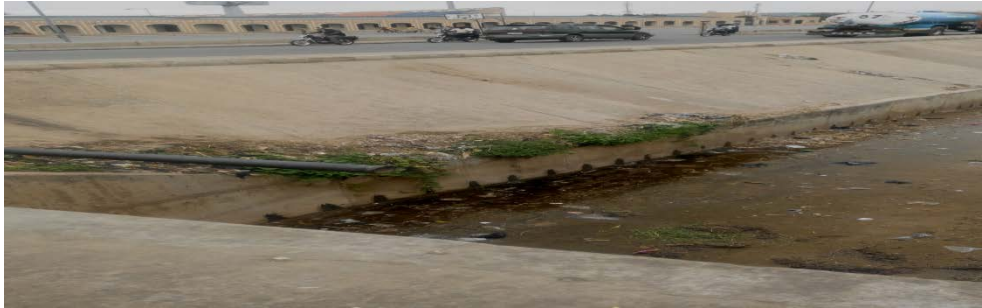
**Plate I: Engineering control measure in Pantami ward (stadium) (N 10°16'30.1", E 011°10'02.5)**

This is the most effective and costly control method of gully erosion in the study area when best practice is adopted and when the full length is executed. Table 4 shows that out of the 131.02 km length of gully erosion inventory in Gombe town 2015 only 35.92 km length has been controlled under

engineering method representing 27.2 %. Comparing the 2003 estimates of 13.22 km, there has been improvement in engineering control methods over the years.

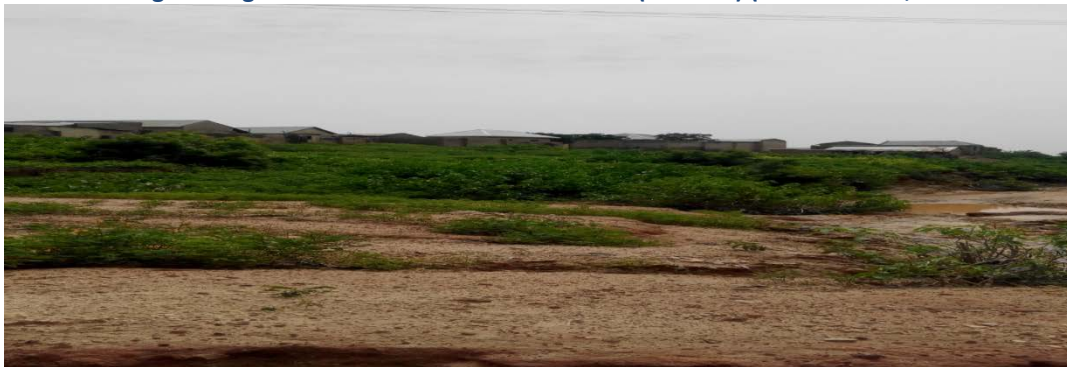
**Plate II: Vegetative control measure (Pantami ward, N10°16'30.1", E11°10'02.5<sup>11</sup>)**

The main reason for this success is connected to street/ roads construction which are also accompanied by construction of drainages more especially in Federal lowcost, Kumbiya Kumbiya, Dawaki, Jagada Fari, and shongo estate among others. Table 4 shows only 5.1 km length of vegetation used in gully erosion control measures out of the total 35.92 km length of the three methods of control measures under study, representing 14.19% and 3.89% of the total lengths of gullies in the study area. The main type of vegetation used is that of *paniculatu / Pitadeniastrum africanum* (kasha kori). This specie of plant is very effective in controlling gully erosion, as it is prone to dryness, survive throughout year, numerous and fine roots density within 0 – 60 cm soil depth, not palatable for animals, affordable and accessible. Unlike engineering method the use of vegetation is cheaper and very fast in stabilizing gully erosion corridors. Most of the areas where vegetation is used are found in low income and sub urban areas where gully erosion menace is devastating and government intervention in terms of engineering method hardly reached. Individual or community efforts contributed to the 5.1 km length of vegetation planted in affected gully erosion corridors.

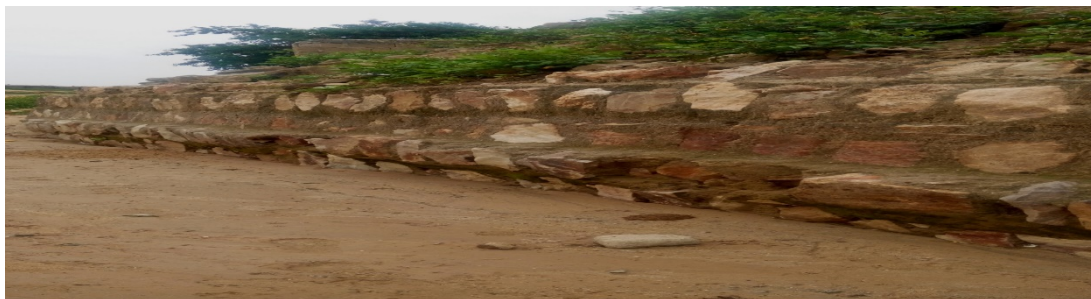
**Plate III: Stonewall Control measure (Tundu Wada ward, N 10018.6451, E11 11.5471)**

Stone wall like engineering method requires capital and technical known how, hence individual or community rarely adopt this method. Table 4 revealed no substantial length (300m) of stone wall used in controlling gully erosion in the study area. However, Gombe State Ministry of Water Resources and Environment (2003) reported that stone wall was the earlier method adopted in controlling gully erosion, but most of it has collapsed hence government decision replacing them with engineering method.

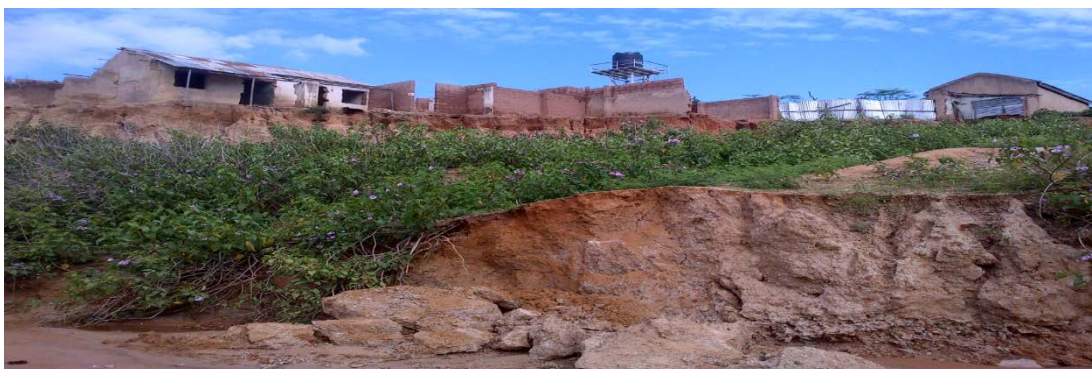
**Plate IV: Uncontrolled gully Gully erosion (Arawa, Shamaki ward N10°18'37.8<sup>11</sup> E11°10'43.5<sup>11</sup>)**
